*Project ref: TV241020*

SITE: 45 The Broadway  
Haywards Heath  
West Sussex  
RH16 3AS

# ***CCTV Survey Report***

*Sewer Inspection, Cleaning and Repair*

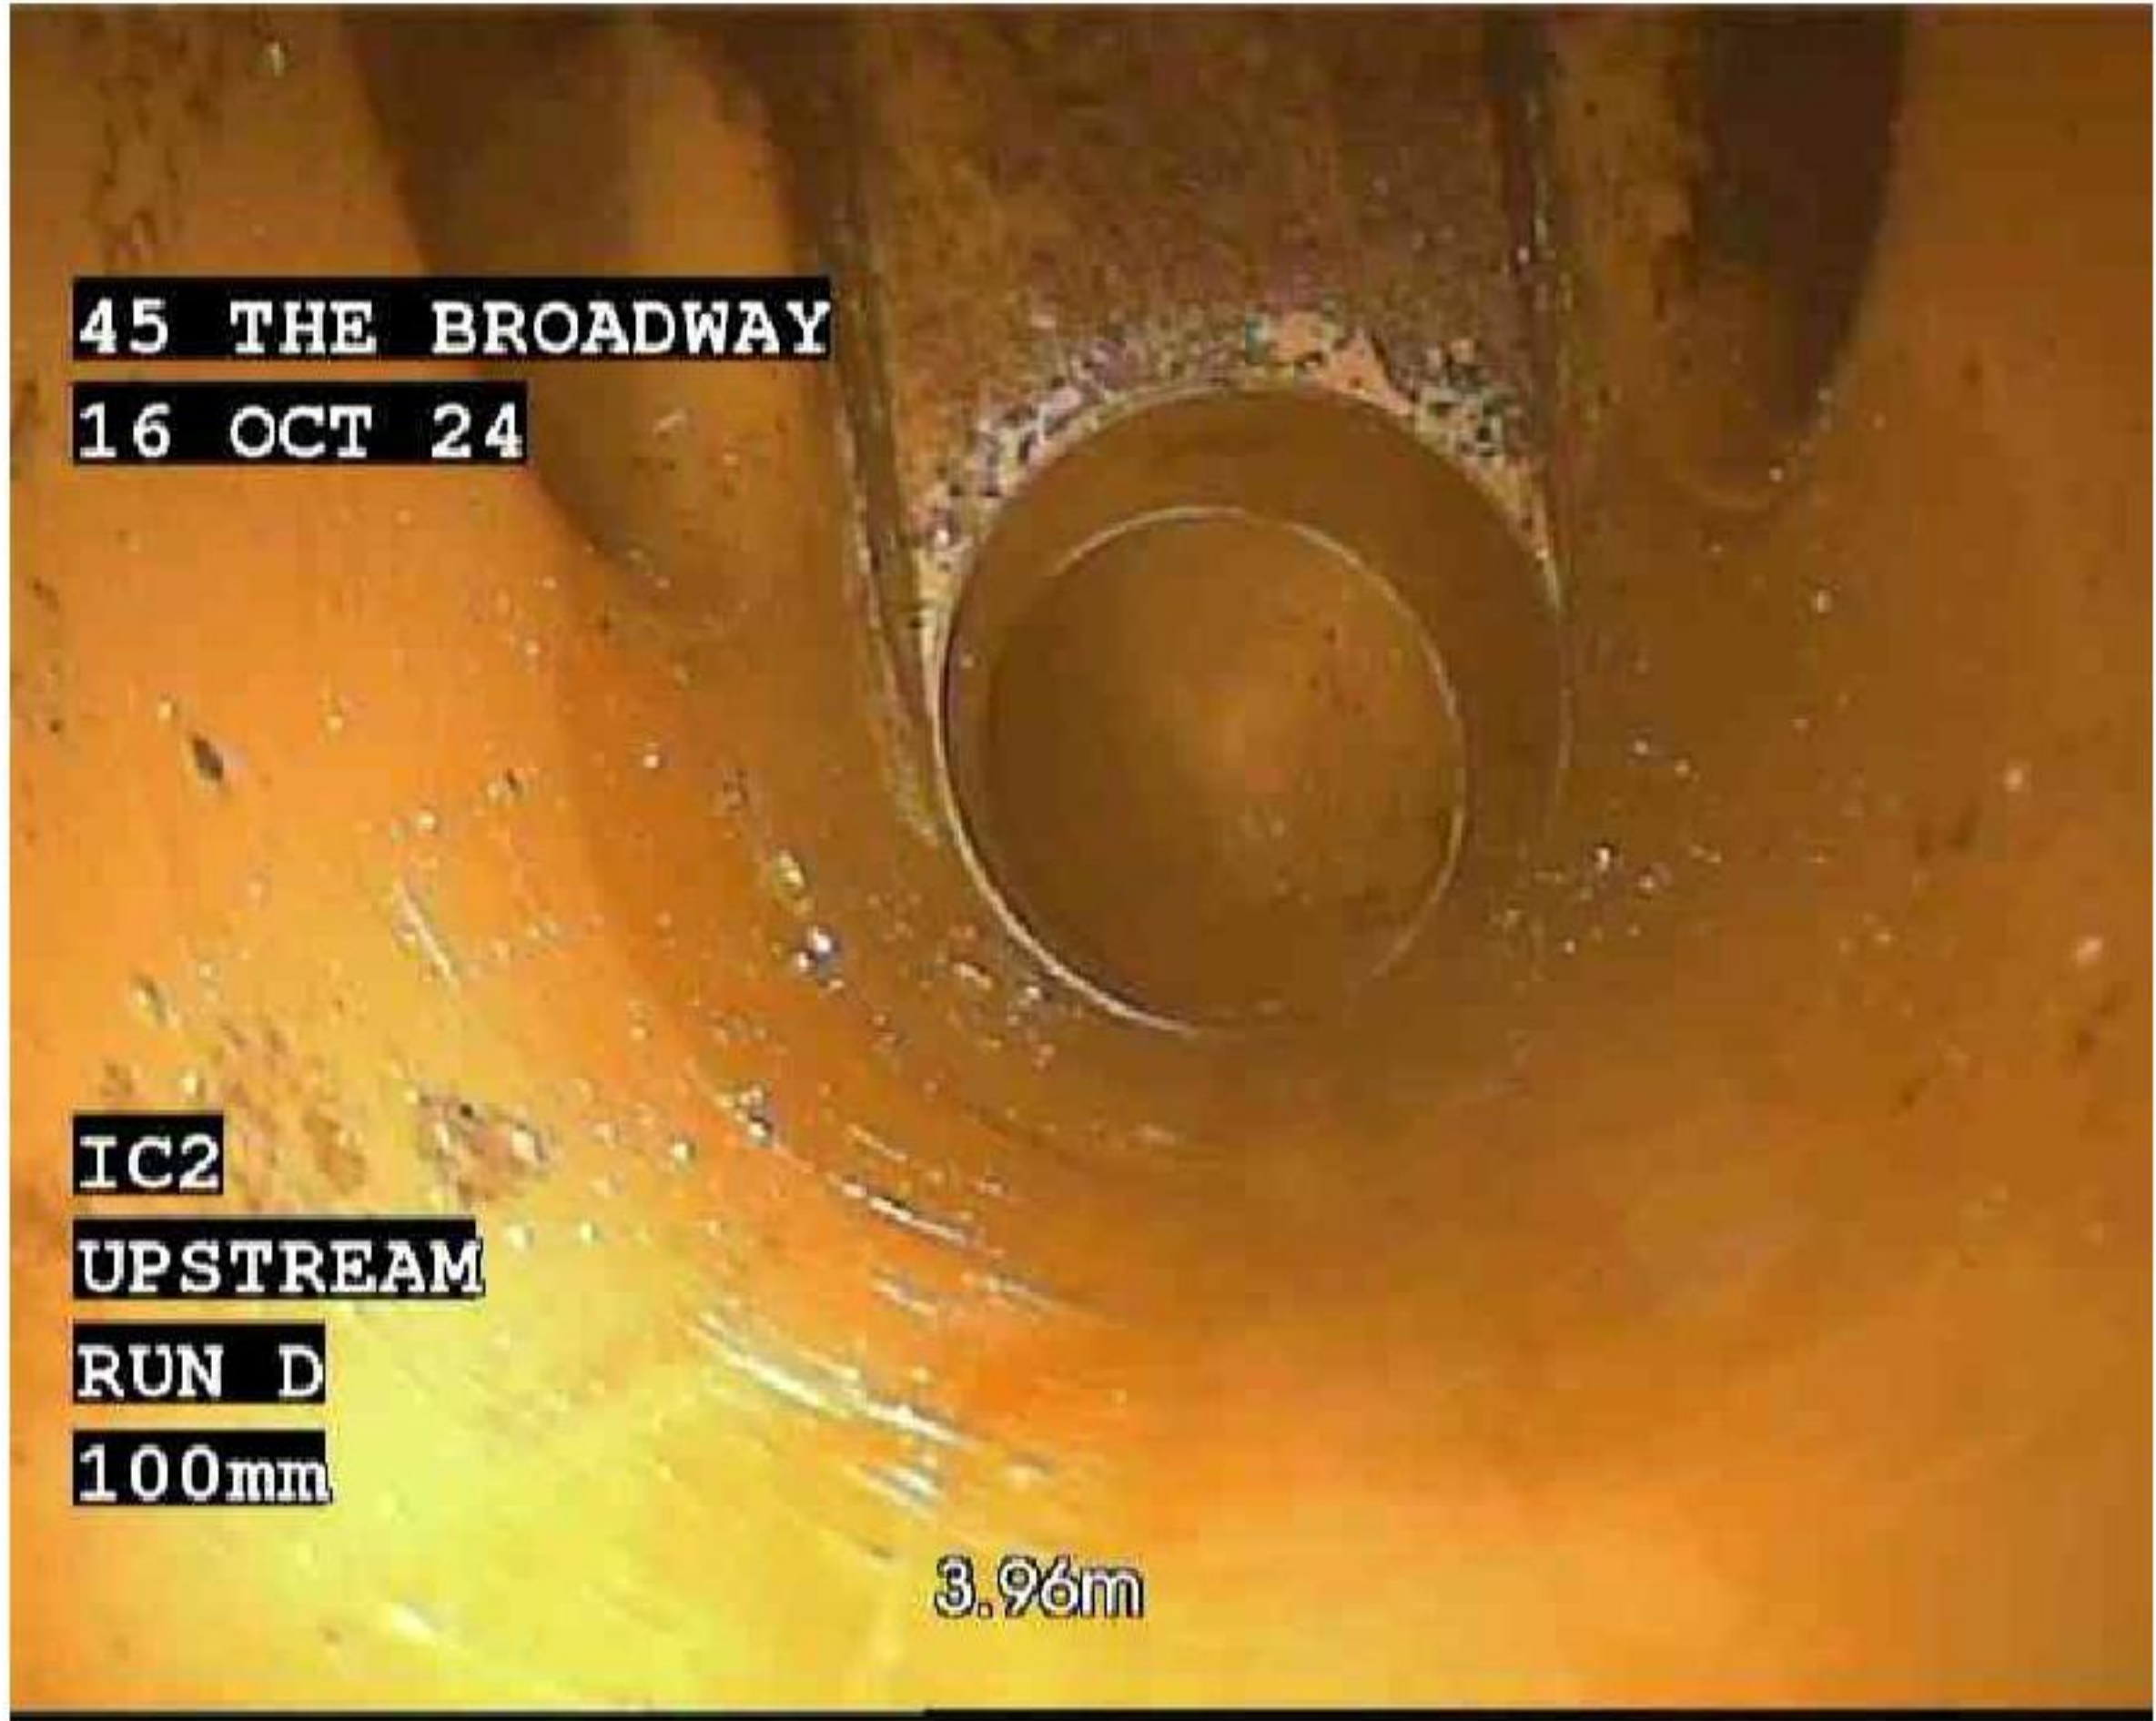
1, 00:00:30, 3.96 m  
Finish node, manhole, reference: IC4
