AN ARCHAEOLOGICAL INTERPRETIVE STUDY FOR  
KEYSFORD BARN, TREEMANS ROAD, HORSTED KEYNES,  
WEST SUSSEX, RH17 7EA.

Report number: ASL 354-25

*This three bay threshing barn was built in the late 16<sup>th</sup> – early 17<sup>th</sup> century [Period A] with some significant alterations carried out during the early-late 19<sup>th</sup> century [Period B] and in the 20<sup>th</sup> century [Period C].*

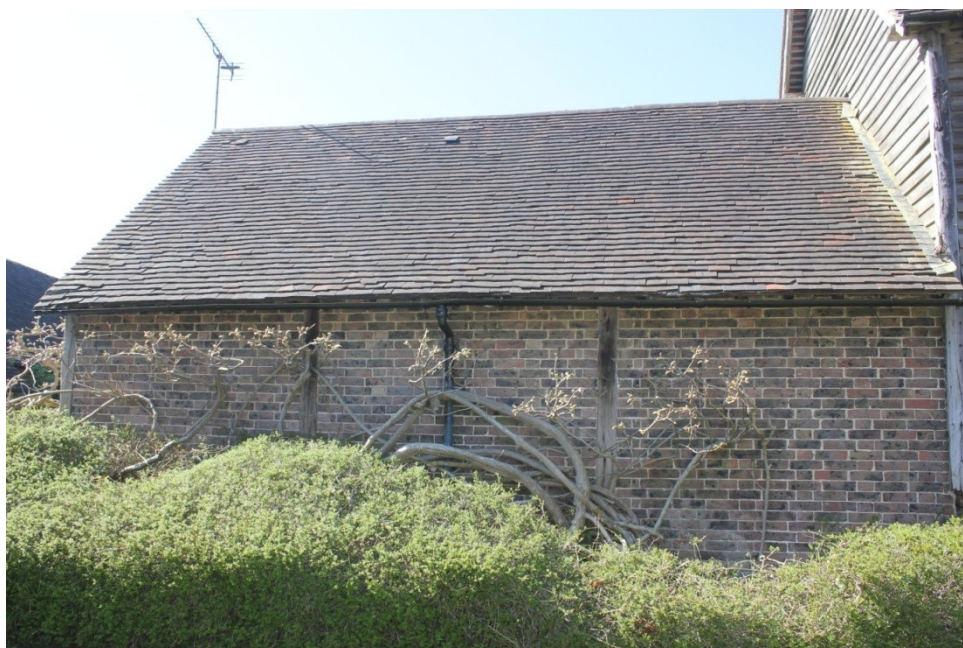
**Plate 62. Front, east elevation of the southern outbuilding.**
