## DRAINAGE STATEMENT

Ote Hall Farm  
Jane's Lane  
Burgess Hill RH15 0SR

**Ref:** 2021-103  
**Issue:** 3  
**Date:** 09 April 2025

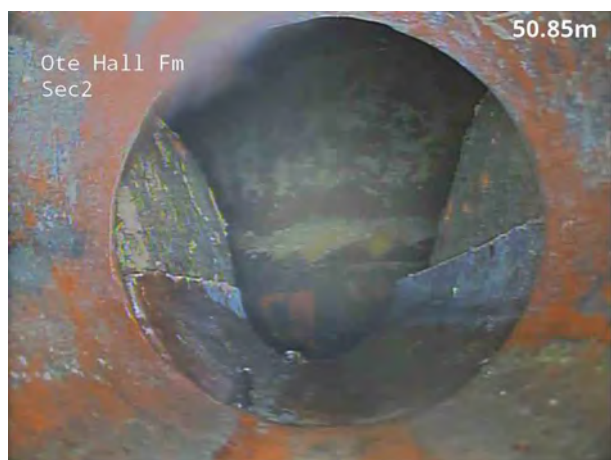
21, 00:01:47, 51.00 m

Finish node, manhole, reference: FW3, Not located
